Memorandum

To: Parking Study Advisory Committee
From: Derrick I. Tokos, AICP, Community Development Director

Date: November 14, 2016
Re: Preliminary Parking Pavement Condition Assessment

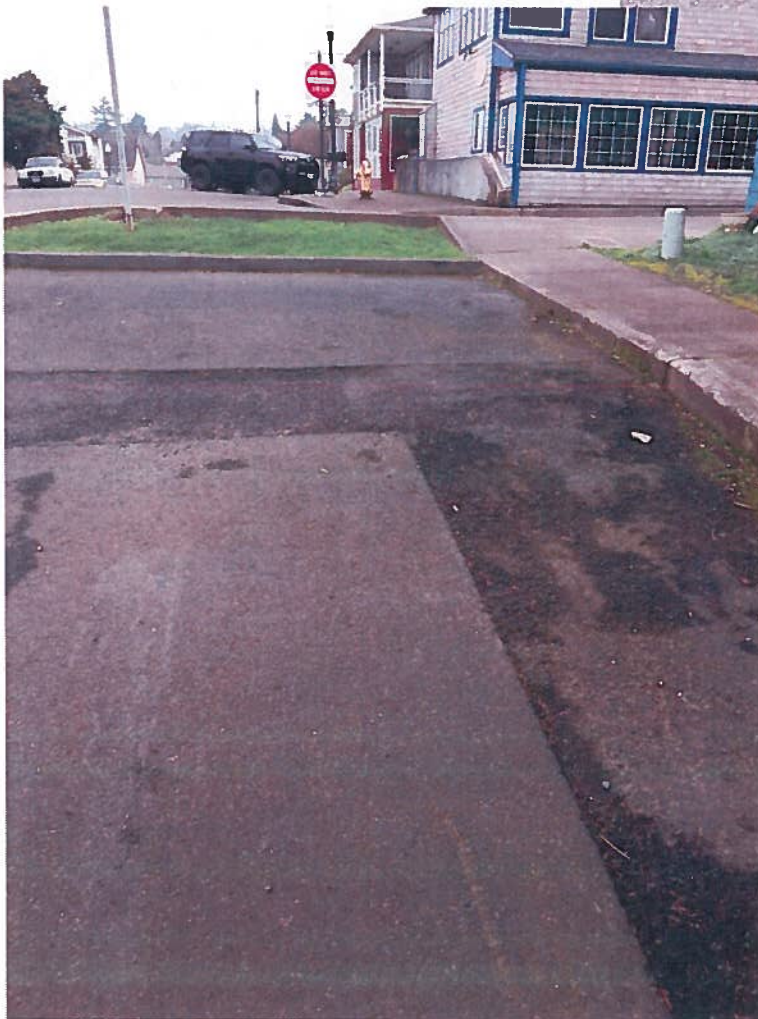
Patching - Visual Arts Center

Patching in itself isn't a problem unless it shows signs of deterioration, deformation or rutting. When pavements are patched, some distress may begin to occur. The rate at which a patch deteriorates is influenced by compaction, materials selection, and the quality of the surrounding or underlying pavement.

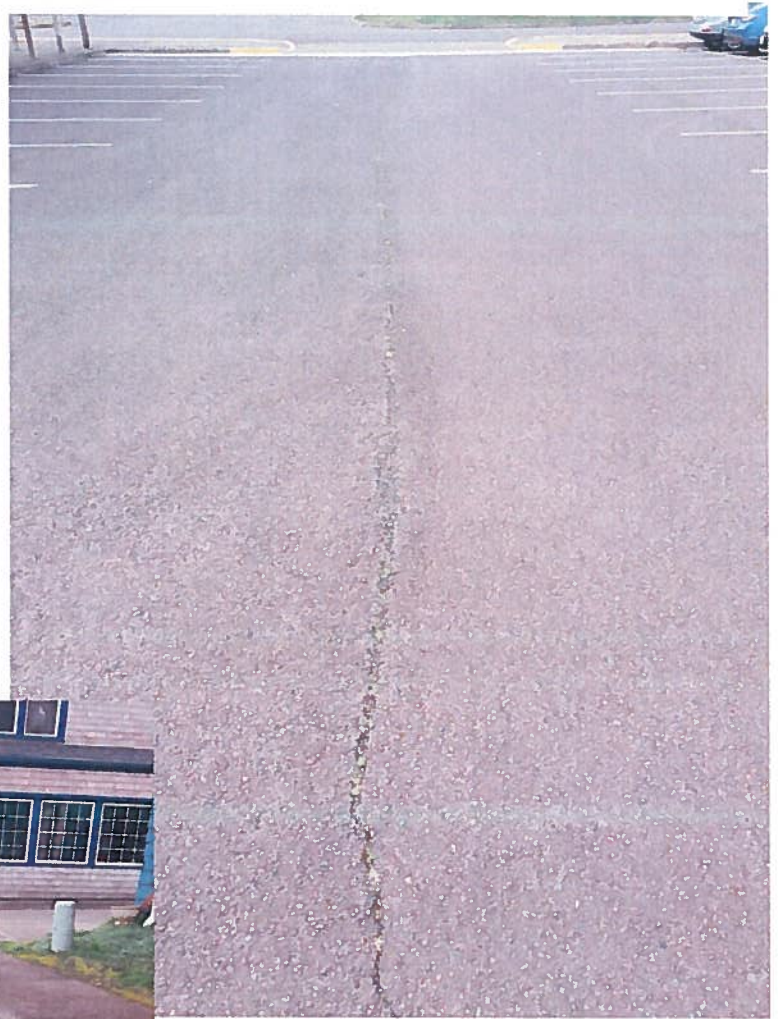
Longitudinal cracking occurs parallel to the centerline of the pavement. It can be caused by a poorly constructed joint; shrinkage of the asphalt layer; cracks reflecting up from an underlying layer; and longitudinal segregation due to improper paver operation.

Longitudinal Cracking - Performing Arts Center

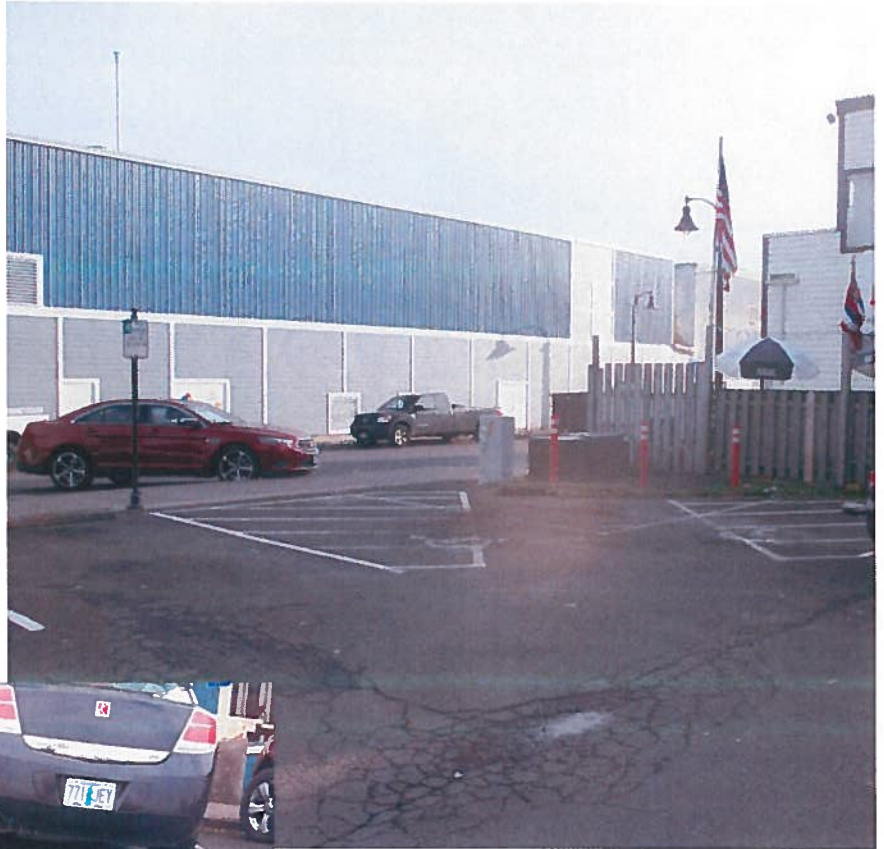
Fatigue cracking is sometimes called alligator cracking due to the interconnected cracks which resemble an alligator's skin. Fatigue cracking is caused by load-related deterioration resulting from a weakened base course or subgrade, too little pavement thickness, overloading, or a combination of these factors.

Fatigue Cracking – Abbey Street Lot

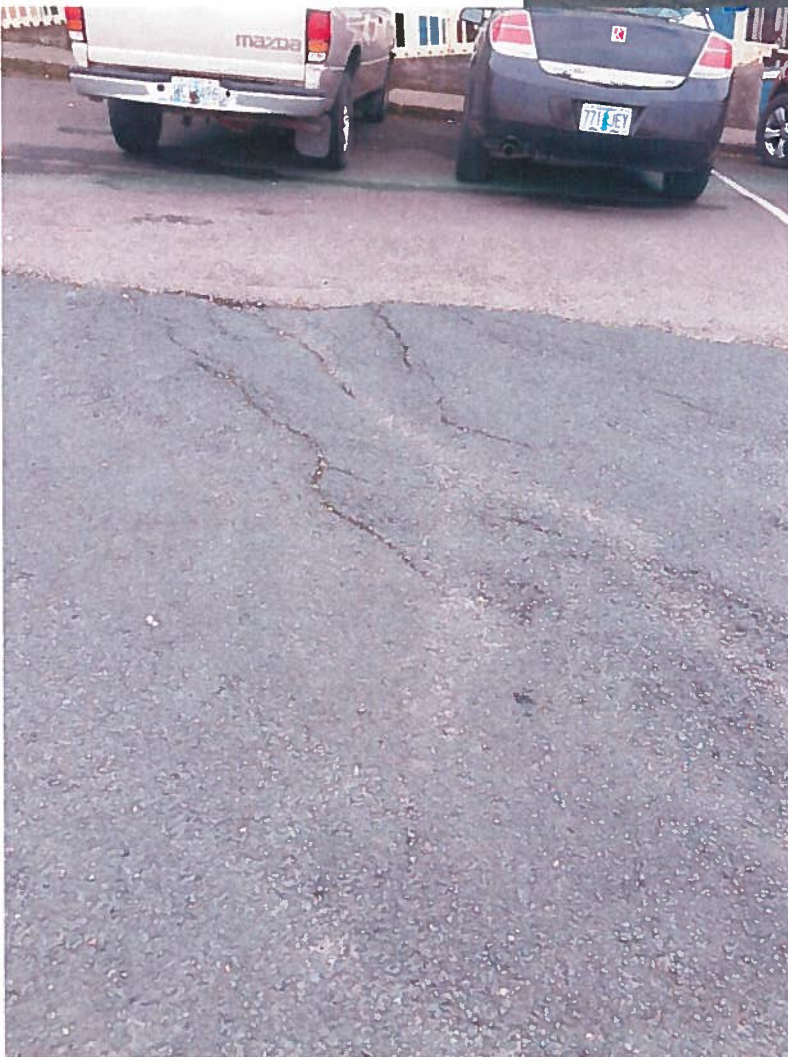
Deformation – Visual Arts Center

A distortion in asphalt pavement that is often attributed to instability of an asphalt mix or weakness of the base or subgrade layers. This type of distress may include rutting, shoving, depressions, swelling and patch failures.

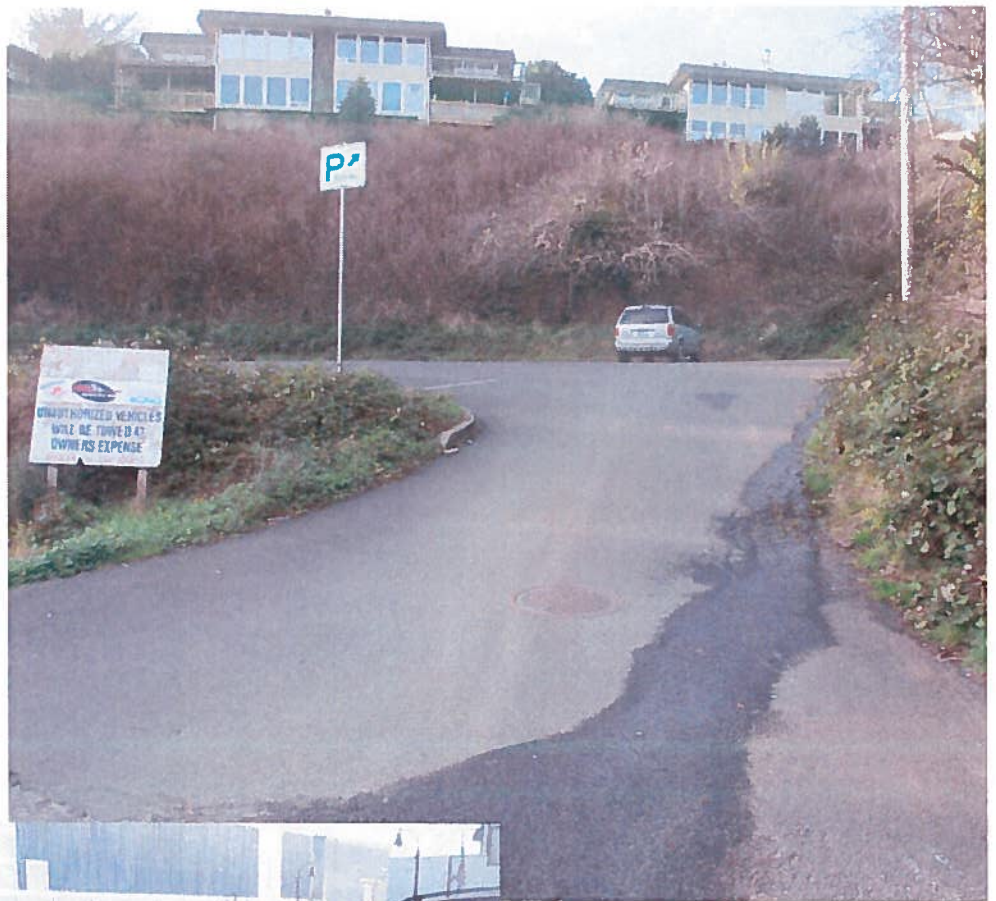
Edge Cracking – Lee Street Lot

Edge cracks are longitudinal cracks which develop within one or two feet of the outer edge of pavement. They form because of a lack of support at the pavement edge; which in this case would be poorly managed drainage that is undermining the road surface

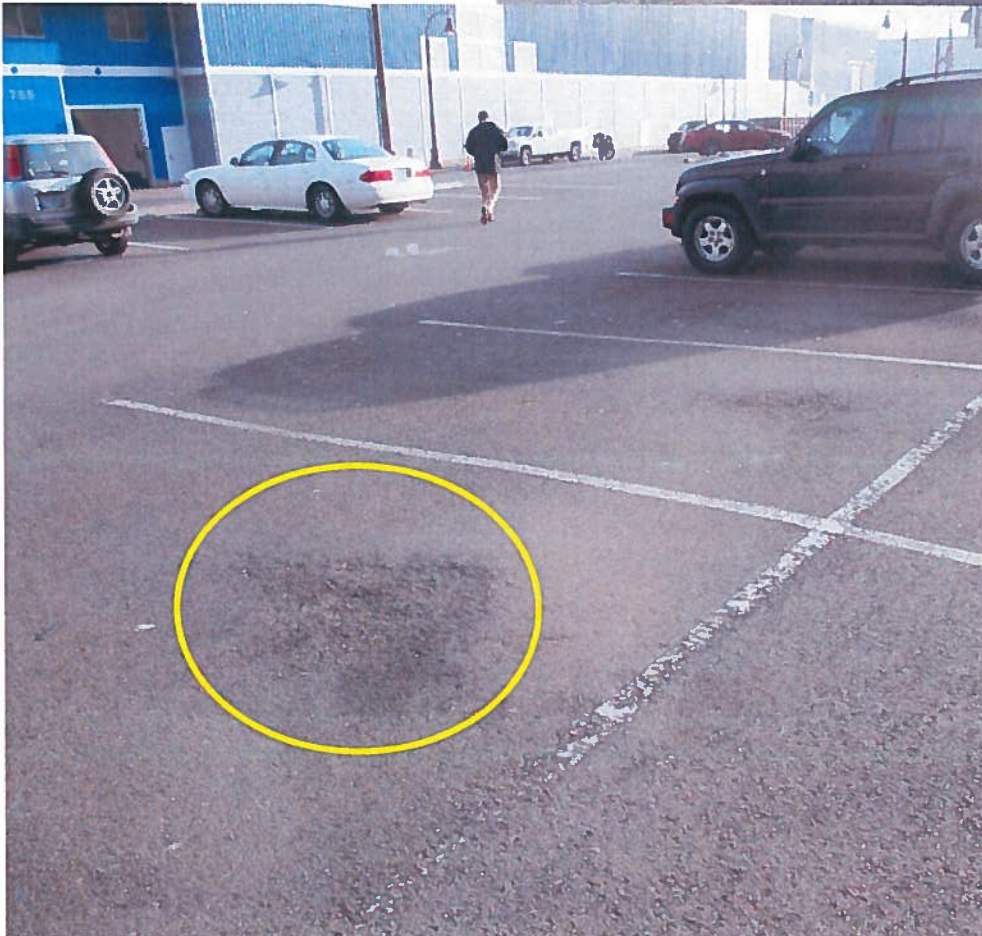
Raveling – Abbey Street Lot

Raveling is the wearing away of the asphalt cement from the aggregate particles. This can occur as a result of normal wear over time and it can be exacerbated by such conditions as oil dripping from vehicles as is evident here at the Abbey Street lot.

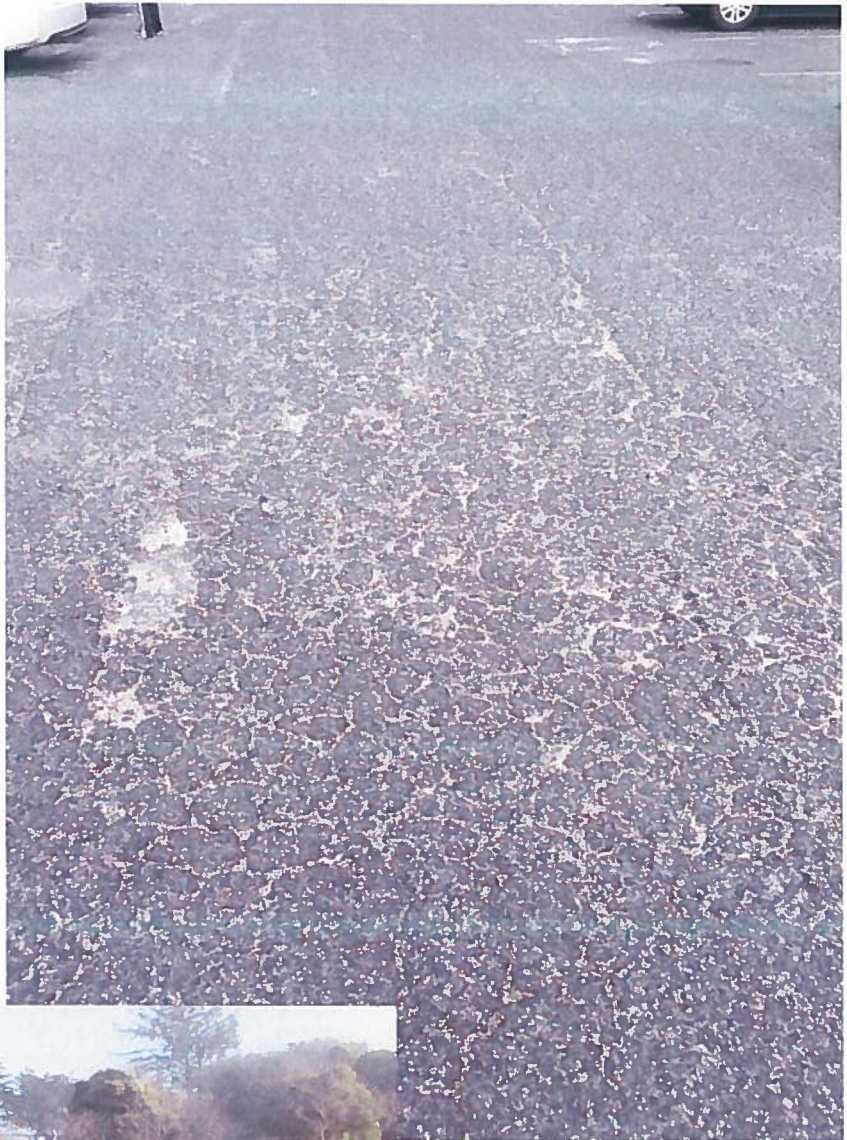
Pavement failure – Nye Beach Turnaround

When pavement conditions wear to the point that there is substantial fatigue cracking, deformation, and/or patching, it can no longer be preserved with a slurry seal and will need to be reconstructed. The Nye Beach Turnaround is an example of a lot that has deteriorated to the point that it must now be replaced.

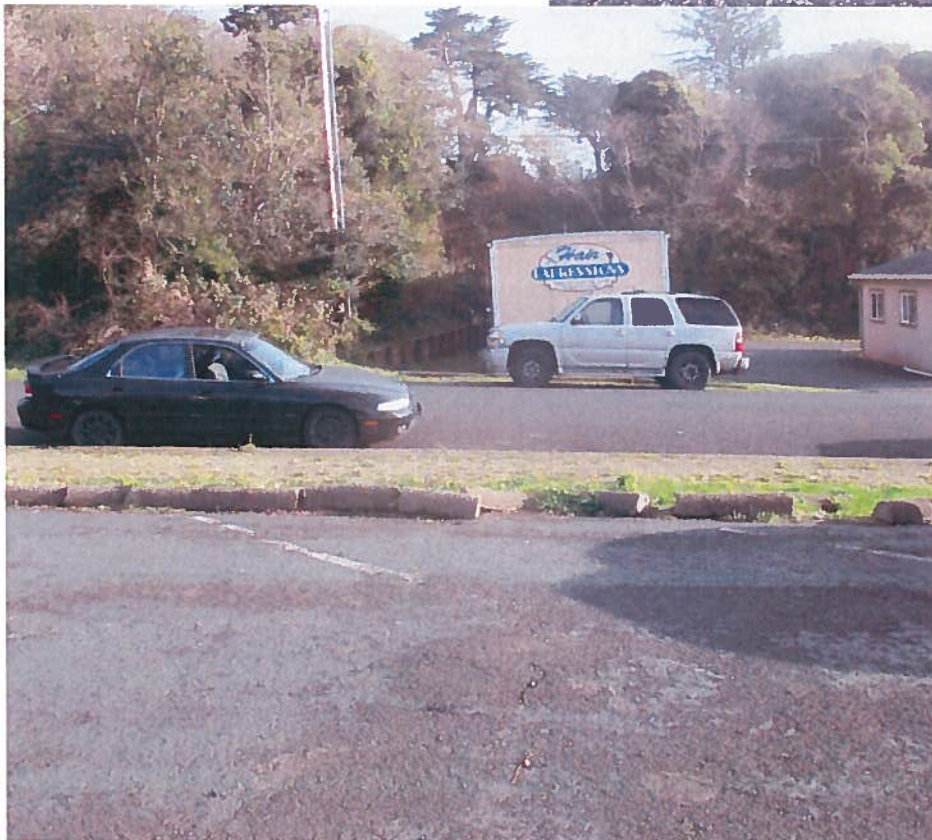
Curb Failure – 9th and Hubert Lot

While not a specific focus of the pavement condition assessment, it was evident that a number of the parking lots have components that need to be replaced or improved, such as the failed curbs at the 9th and Hubert lot (pictured).
