Resilience Assessment Report

Newport Municipal Airport
Newport, Oregon

January 31, 2018
Salus/HC Job #154-035-009
City of Newport Project #2016-007

Salus Resilience/Hart Crowser, Inc. and
Precision Approach Engineering, Inc.

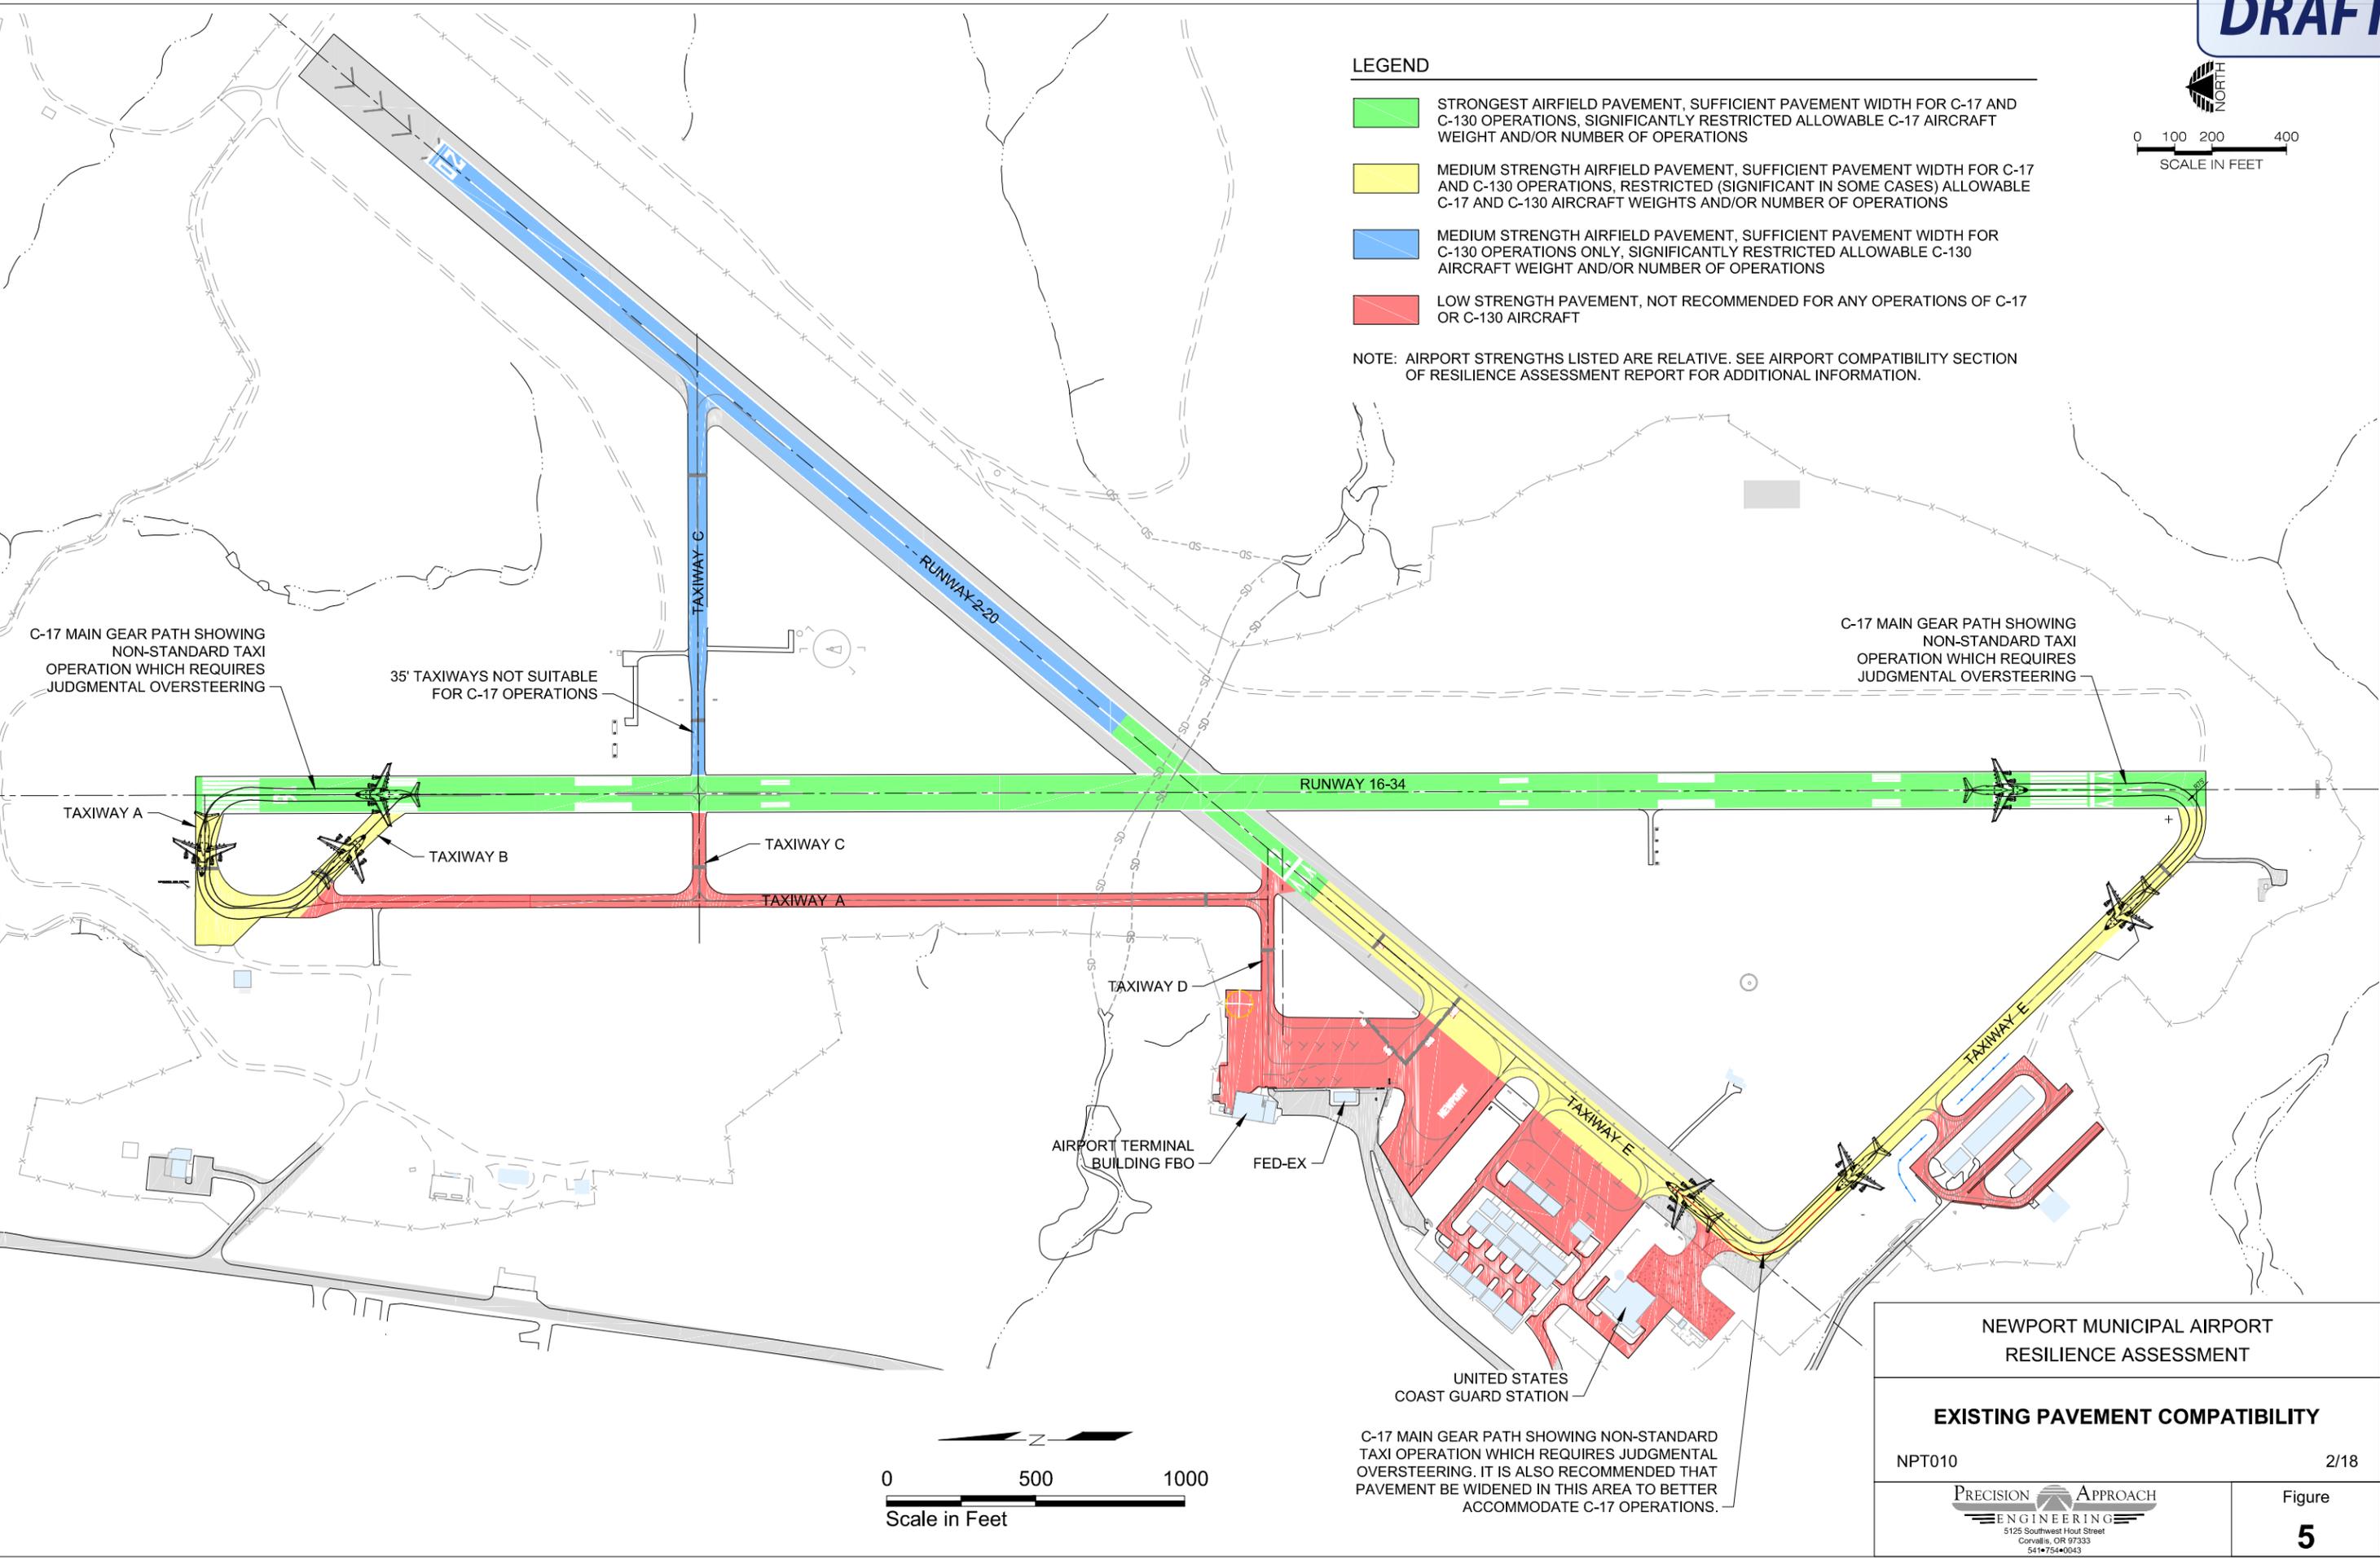
NEWPORT MUNICIPAL AIRPORT RESILIENCE ASSESSMENT	
EXISTING PAVEMENT COMPATIBILITY	
NPT010	2/18
 <small>5125 Southwest Hoyt Street Corvallis, OR 97333 541-754-0043</small>	
Figure 5

C-17 MAIN GEAR PATH SHOWING NON-STANDARD TAXI OPERATION WHICH REQUIRES JUDGMENTAL OVERSTEERING. IT IS ALSO RECOMMENDED THAT PAVEMENT BE WIDENED IN THIS AREA TO BETTER ACCOMMODATE C-17 OPERATIONS.

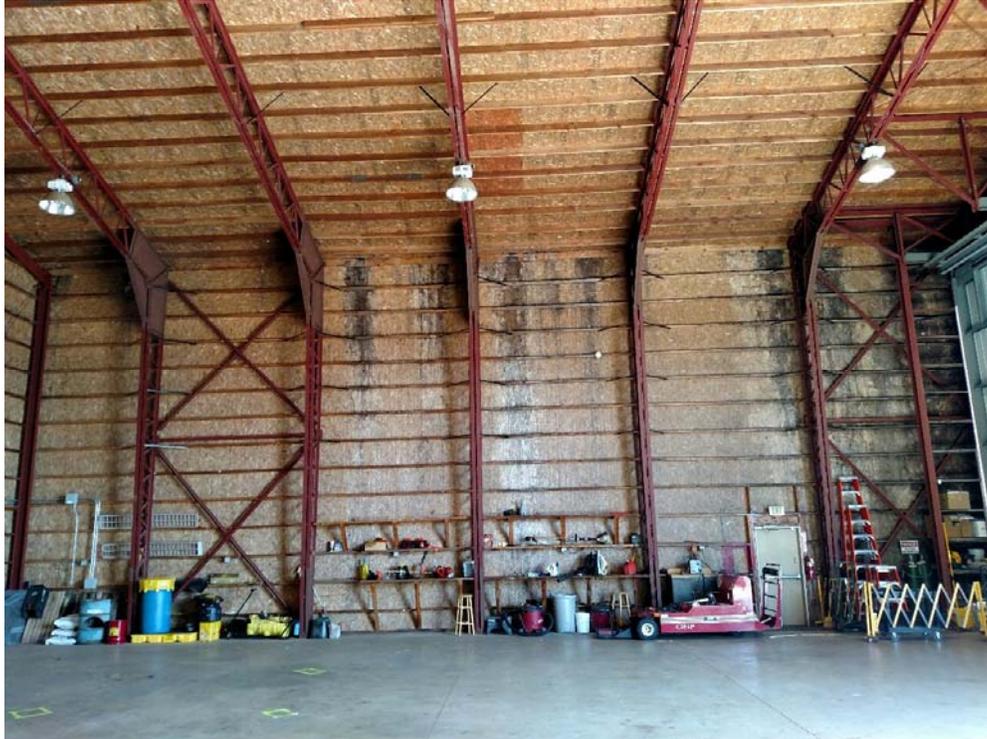
Photo 1 – Interior With Braced Frames and Moment Frames

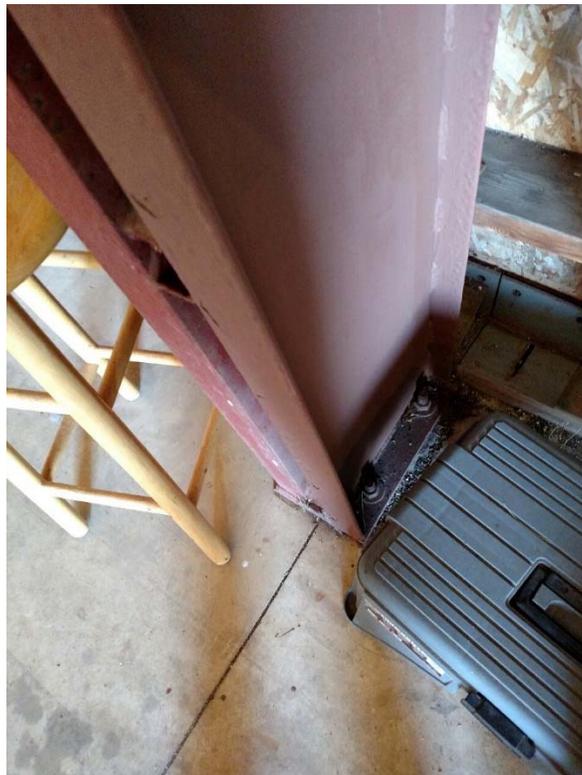
Photo 2 – Building Column with Cladding Removed at Base

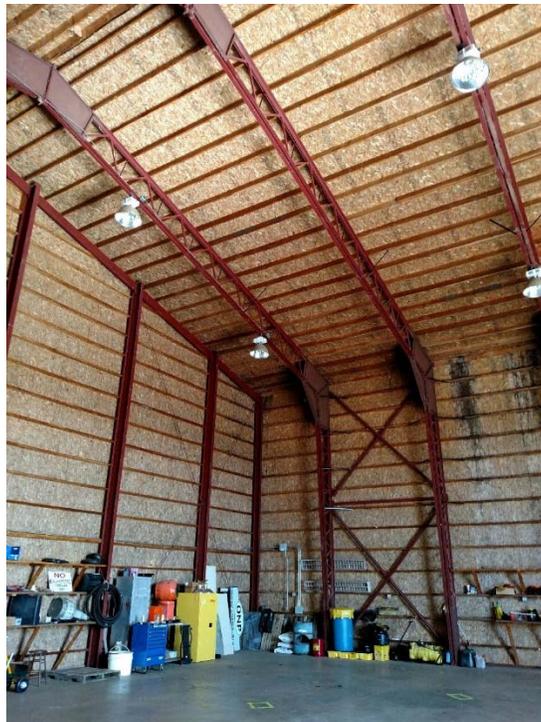
Photo 4 – Interior (Note Unanchored Cabinets)

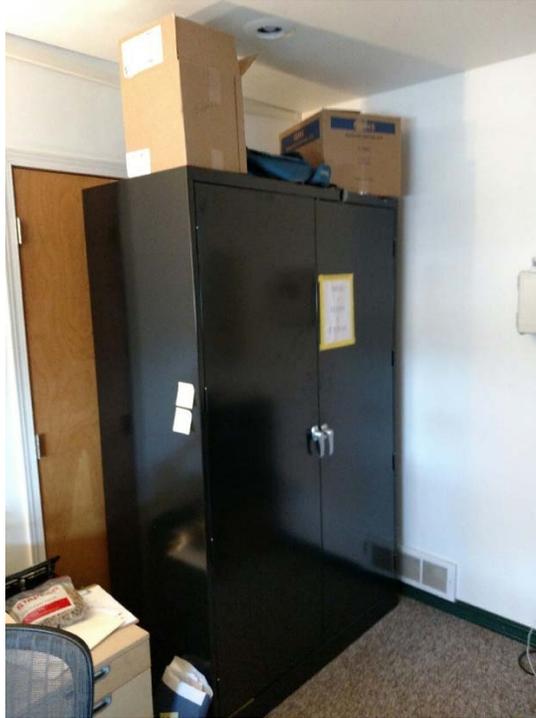
Photo 5 – Unanchored Cabinet w/ Unsecured Contents on Top (Note Proximity to Door)

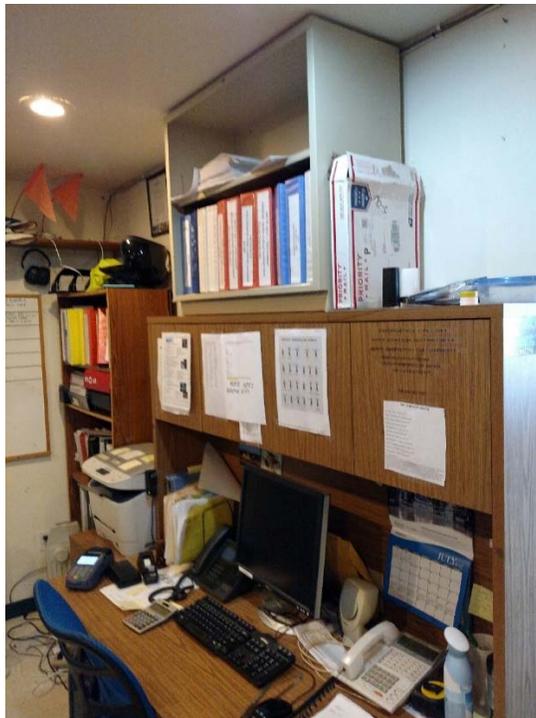
Photo 6 – Unrestrained Heavy Contents

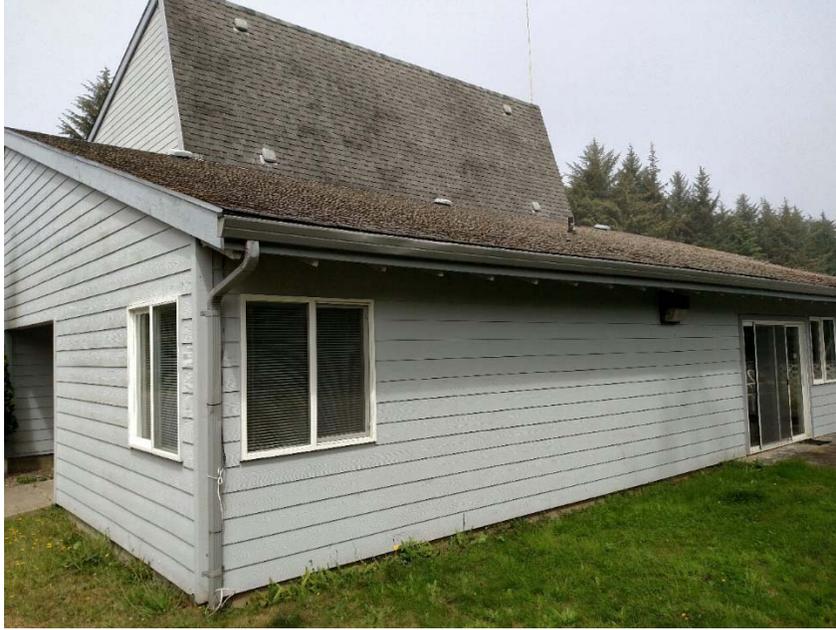
Photo 1 – Step in Roof Diaphragm

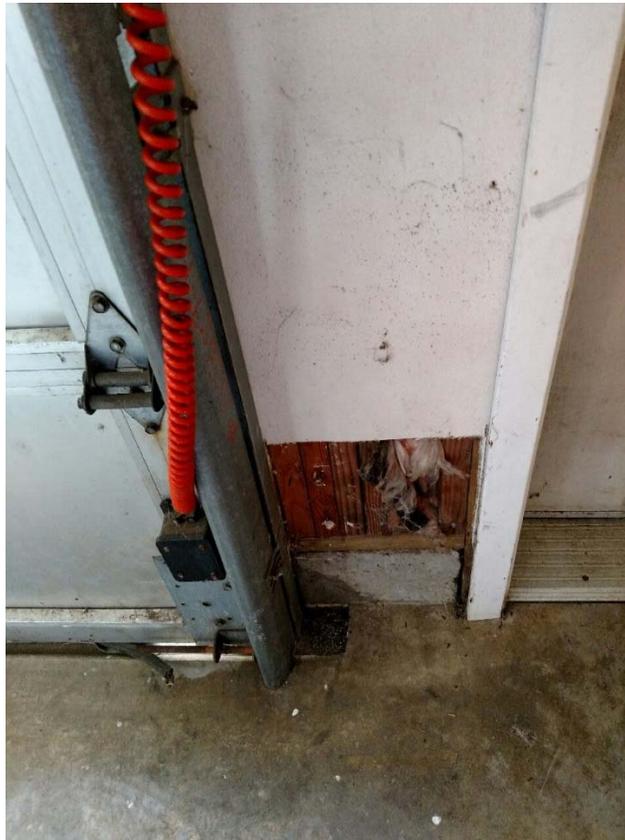
Photo 2 – Existing Sill Plate and Wall Framing

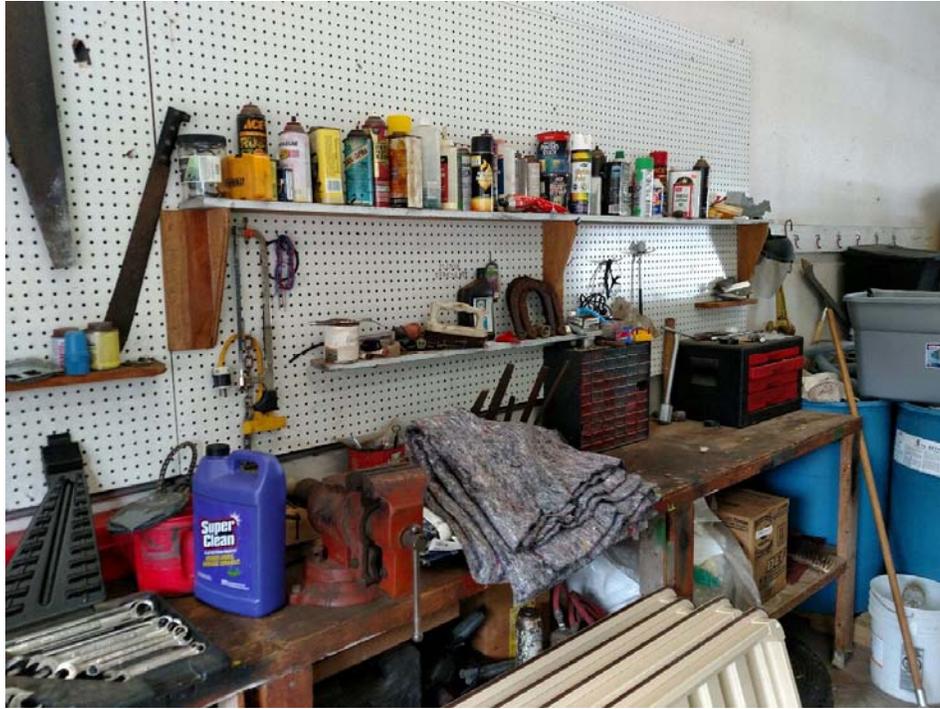
Photo 3 - Shelving w/ Unrestrained Hazardous Materials

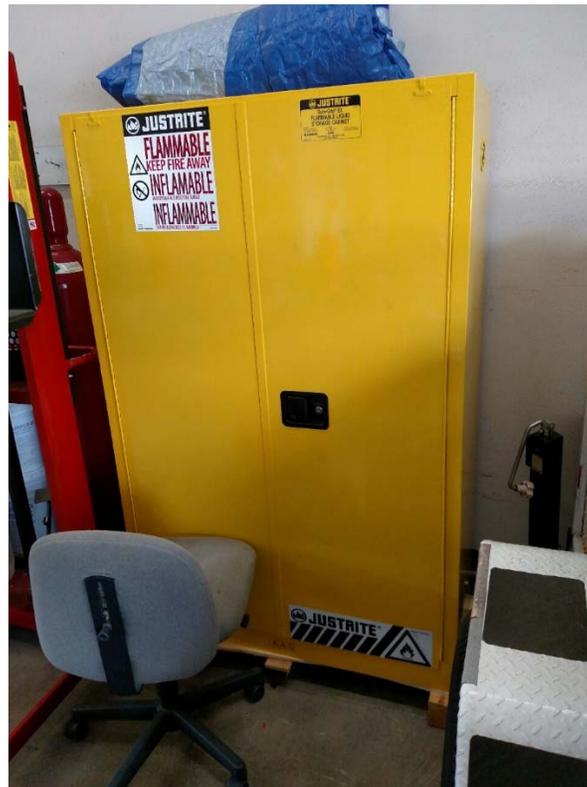
Photo 4 – Unbraced Hazmat Cabinet

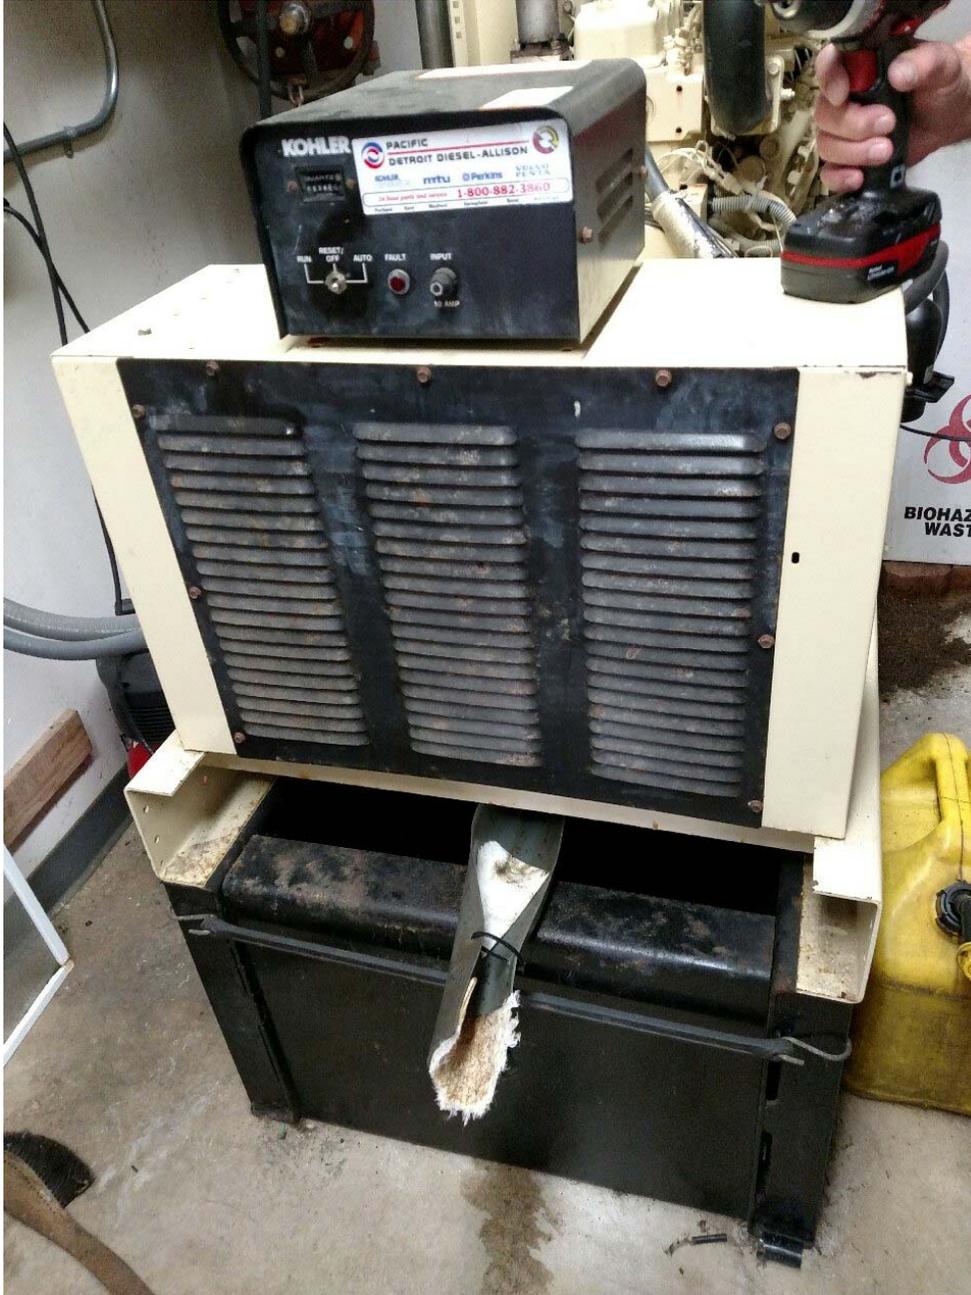
Photo 5 – Unanchored Mech Equipment
