Wetland Delineation

Newport Municipal Airport Obstruction Removal

Re: WD # 2020-0008 Approved (Correction) Report for Newport Municipal Airport Obstruction Removal Lincoln County; T11S R11W S29 and T11S R11W S32 Includes Multiple Tax Lots (see attached maps)

NEWPORT MUNICIPAL AIRPORT OBSTRUCTION REMOVAL WATER RESOURCE DELINEATION REPORT

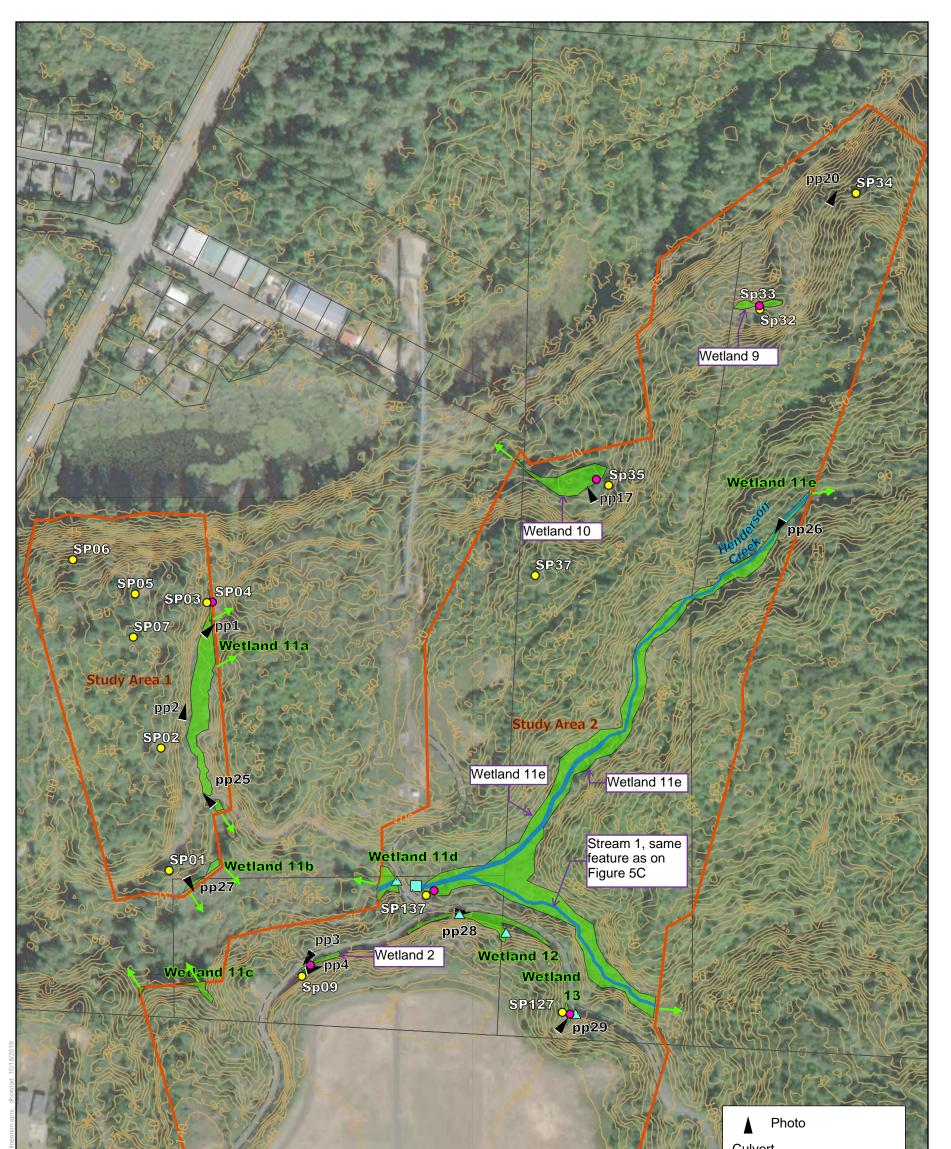
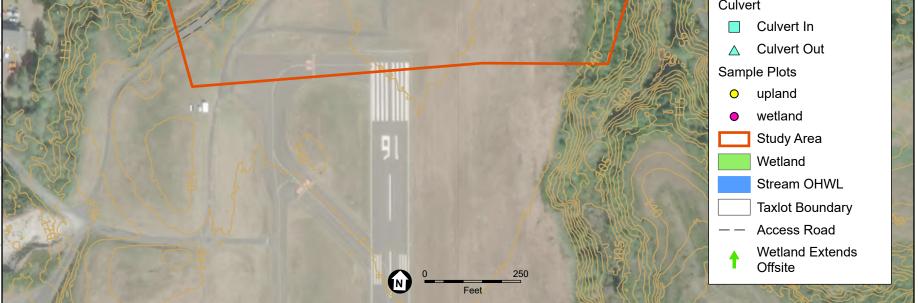
Figure 5B Wetland Delineation Map Lincoln County, OR

Accuracy Statement: Sample Points and wetland and waterway boundaries were flagged in the field and mapped using a Bad Elf GNSS surveyor bluetooth receiver and a tablet data collector (1m positional accuracy). D171238.00 Newport Airport EA

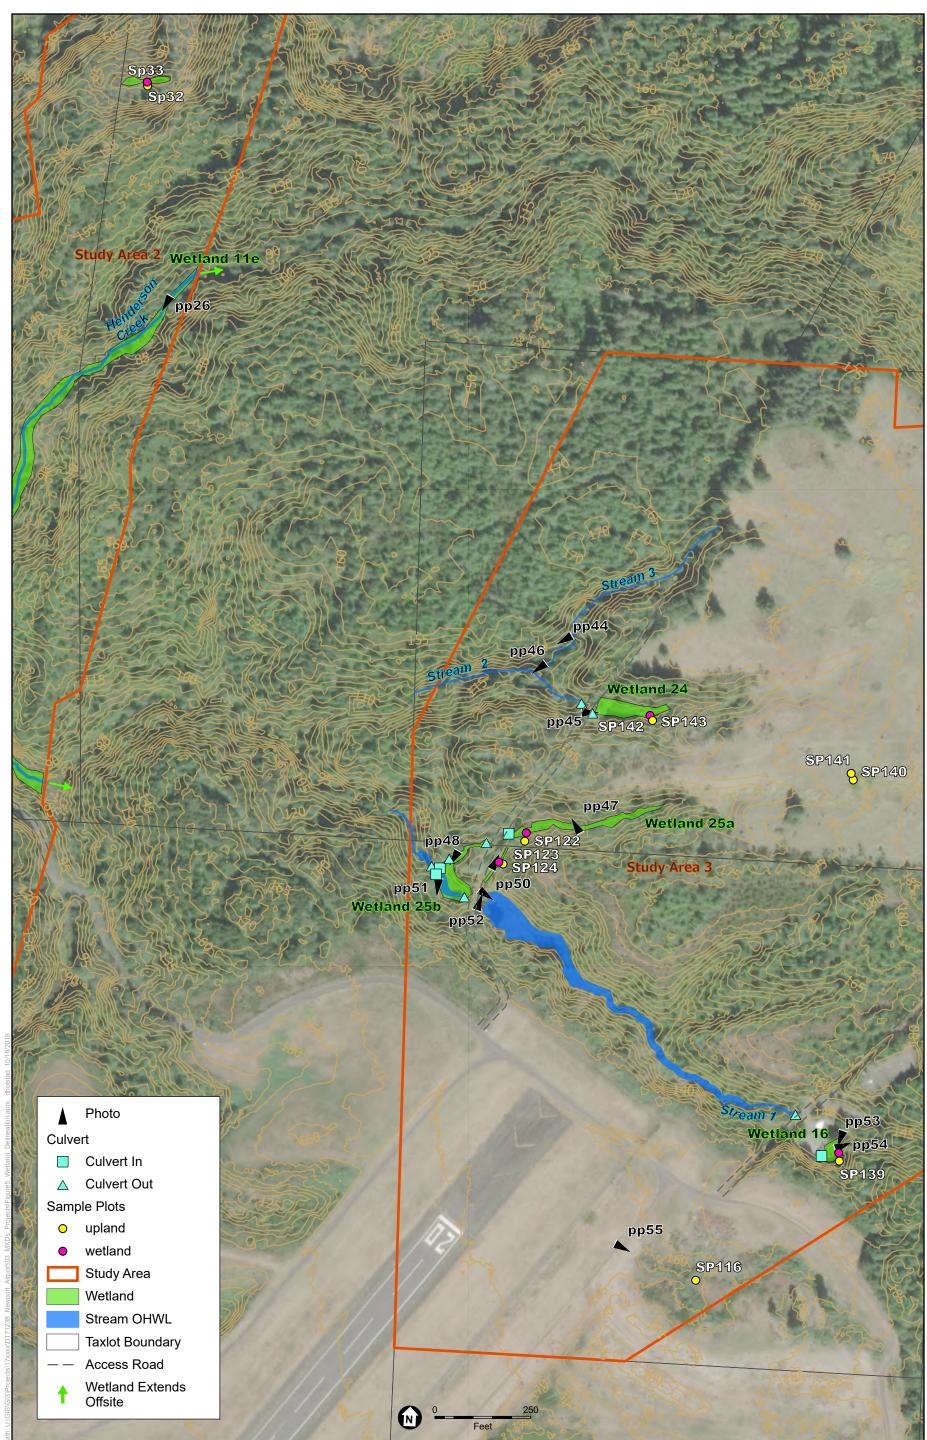
Figure 5C Wetland Delineation Map Lincoln County, OR

Accuracy Statement: Sample Points and wetland and waterway boundaries were flagged in the field and mapped using a Bad Elf GNSS surveyor bluetooth receiver and a tablet data collector (1m positional accuracy).

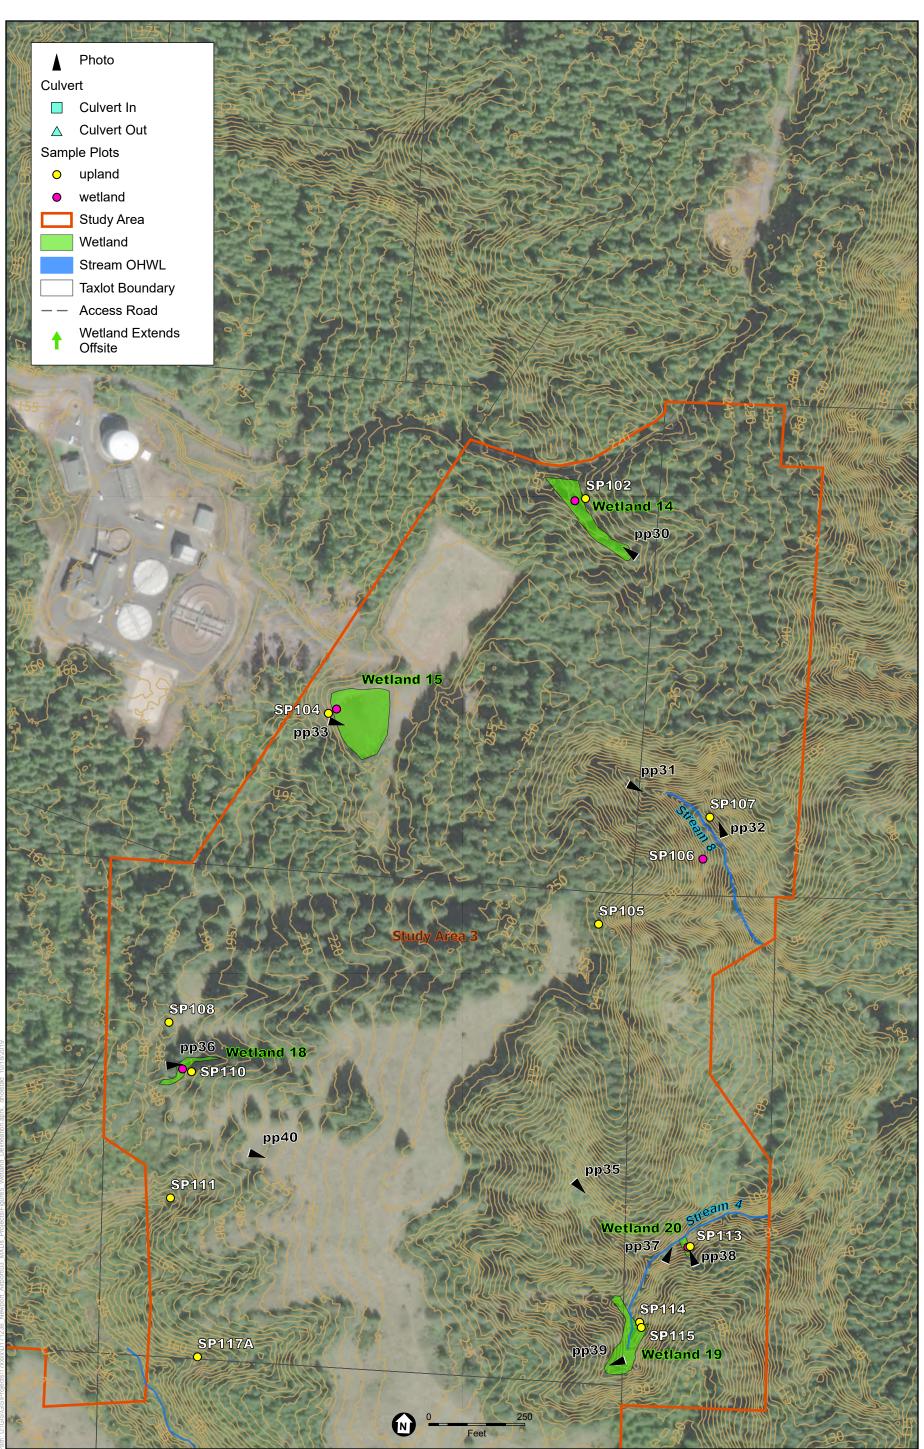
Figure 5D Wetland Delineation Map Lincoln County, OR

Accuracy Statement: Sample Points and wetland and waterway boundaries were flagged in the field and mapped using a Bad Elf GNSS surveyor bluetooth receiver and a tablet data collector (1m positional accuracy). D171238.00 Newport Airport EA

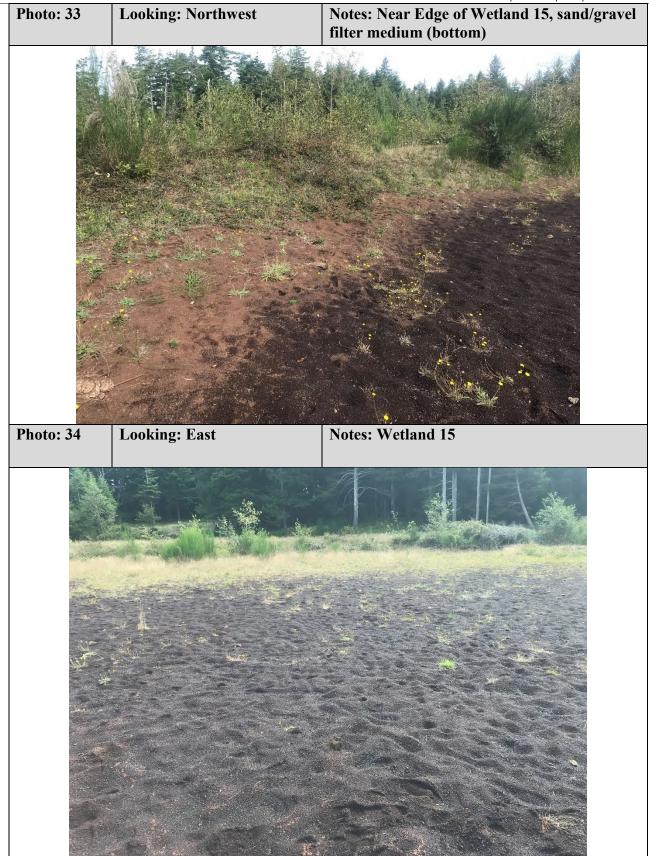
Photo: 35	Looking: Southeast	Notes: Upland alder forest within topographic drainage feature
Photo: 36	Looking: Southwest	Notes: Standing on upland plateau, looking into Wetland 18
		<image/>
