8-GP-18

Lots 1-3, Block 49, Oceanview subdivision – Tax lot 2300 Map 11-11-05-BB (NW Spring St)

Applicants: J.T. Roth, Jr. & Theresa Roth

Comment: Proposed Development in the Geologic Hazard Zone, Active Slide Area

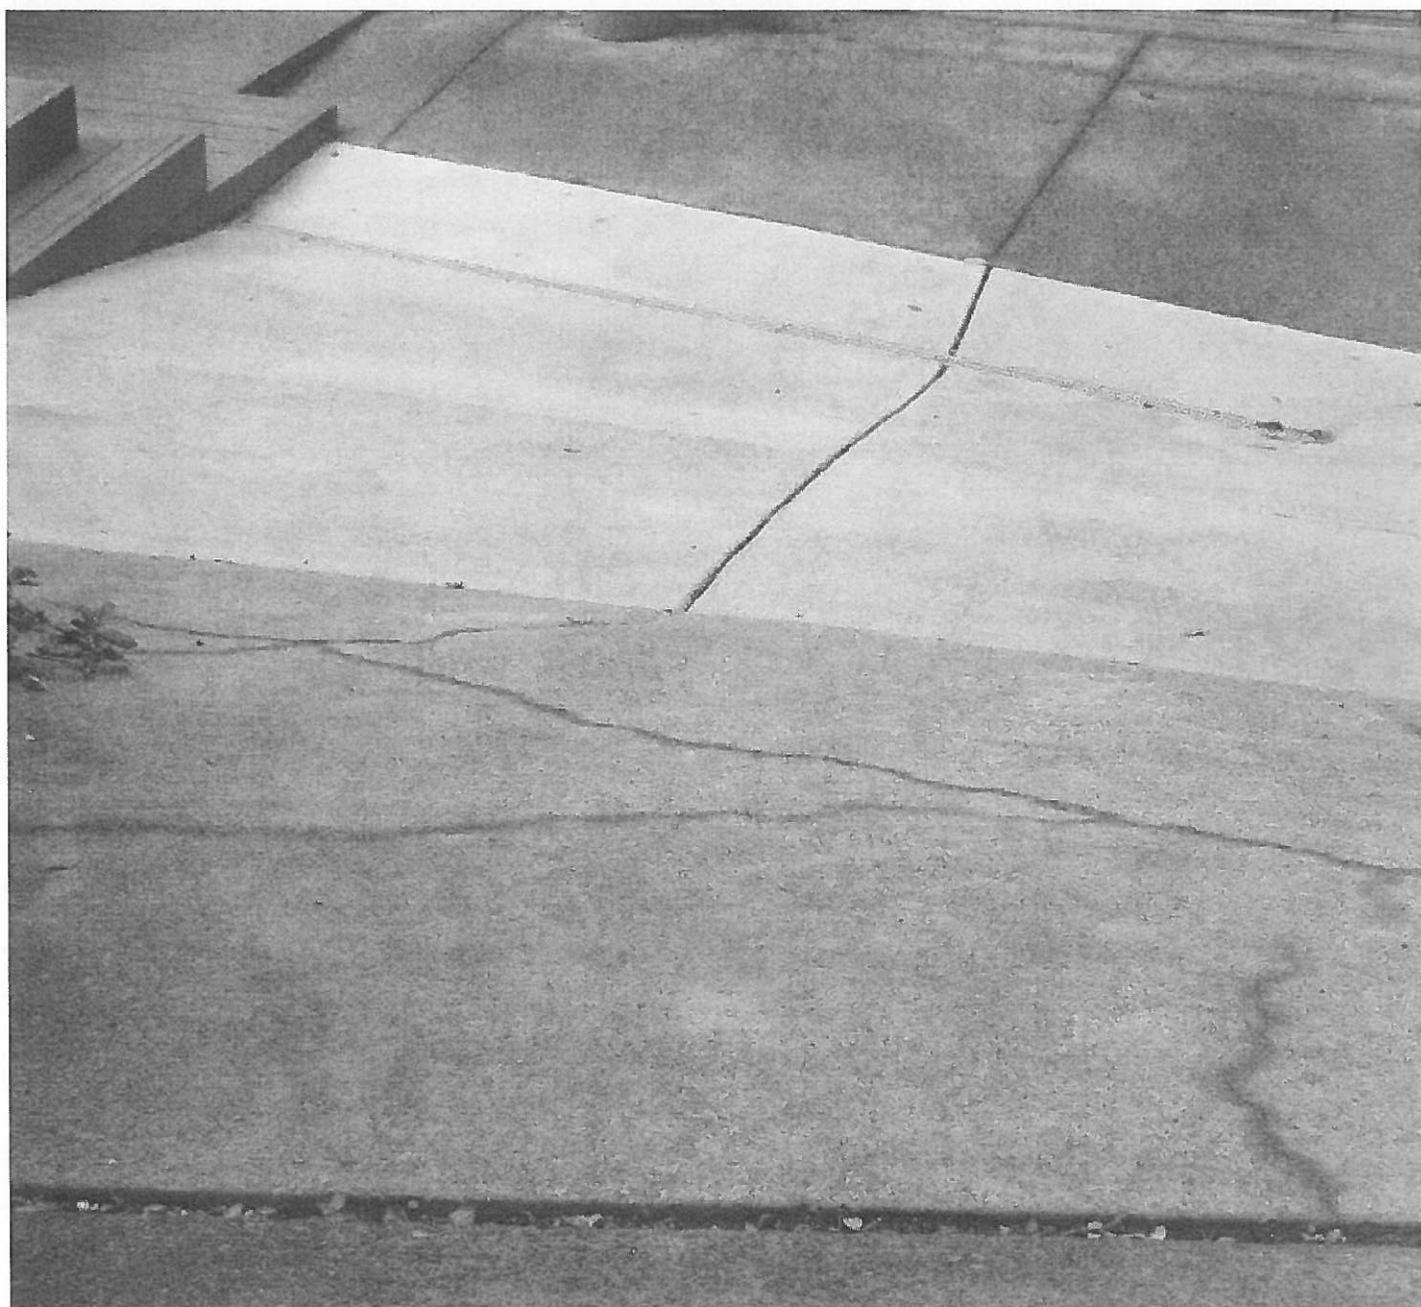
1409 NW Spring St. Photo from 1-GP-18

- 1. 1409 Spring St, cracks in driveway (1-GP-18)**
- 2. Recent slide scarp west of the condos on NW Spring and 12th and east of the old Jump-off Joe debacle. Second photo is new down dropped block in the old foundation.**

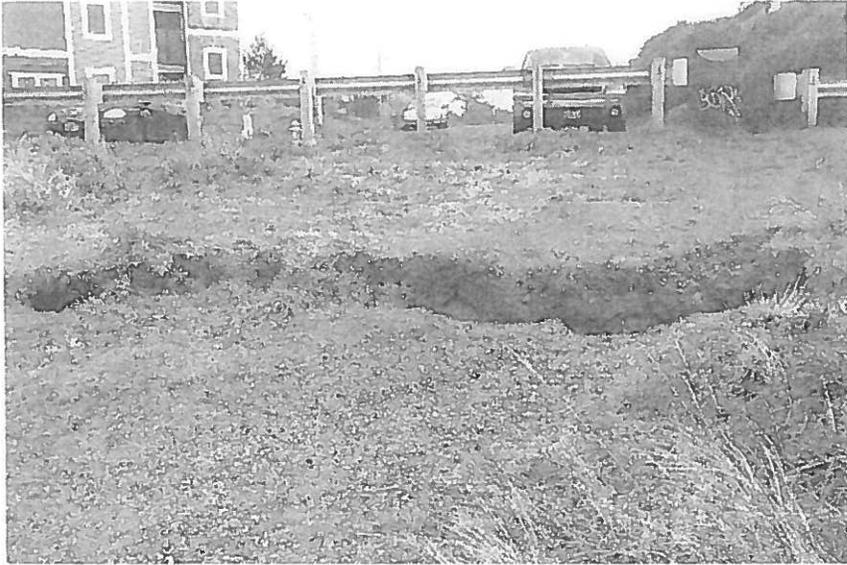
Recent Slide Scarp - see attribution End Notes page

This active slide area extends further south and north. Cracks in pavement are just an indicator. See the photo (End Notes) of a recent slide scarp west of the condos on NW Spring and 12th and east of the old Jump-off Joe debacle. This is the crux of the emerging picture of NW Spring St. with yet more development proposed on the west side. The larger picture gets lost when isolating individual lots, as if lot lines define geologic attributes. With the stormwater drainage issues on this street and at this intersection, I am concerned that admonishing the developer to adhere exactly to the long list of recommendations (especially with no independent vetting of technical detail or guarantee of adequate oversight) will not be sufficient and may put this coastal area and Spring St. at risk.
