Resilience Assessment Report

Newport Municipal Airport
Newport, Oregon

January 31, 2018
Salus/HC Job #154-035-009
City of Newport Project #2016-007

Salus Resilience/Hart Crowser, Inc. and
Precision Approach Engineering, Inc.

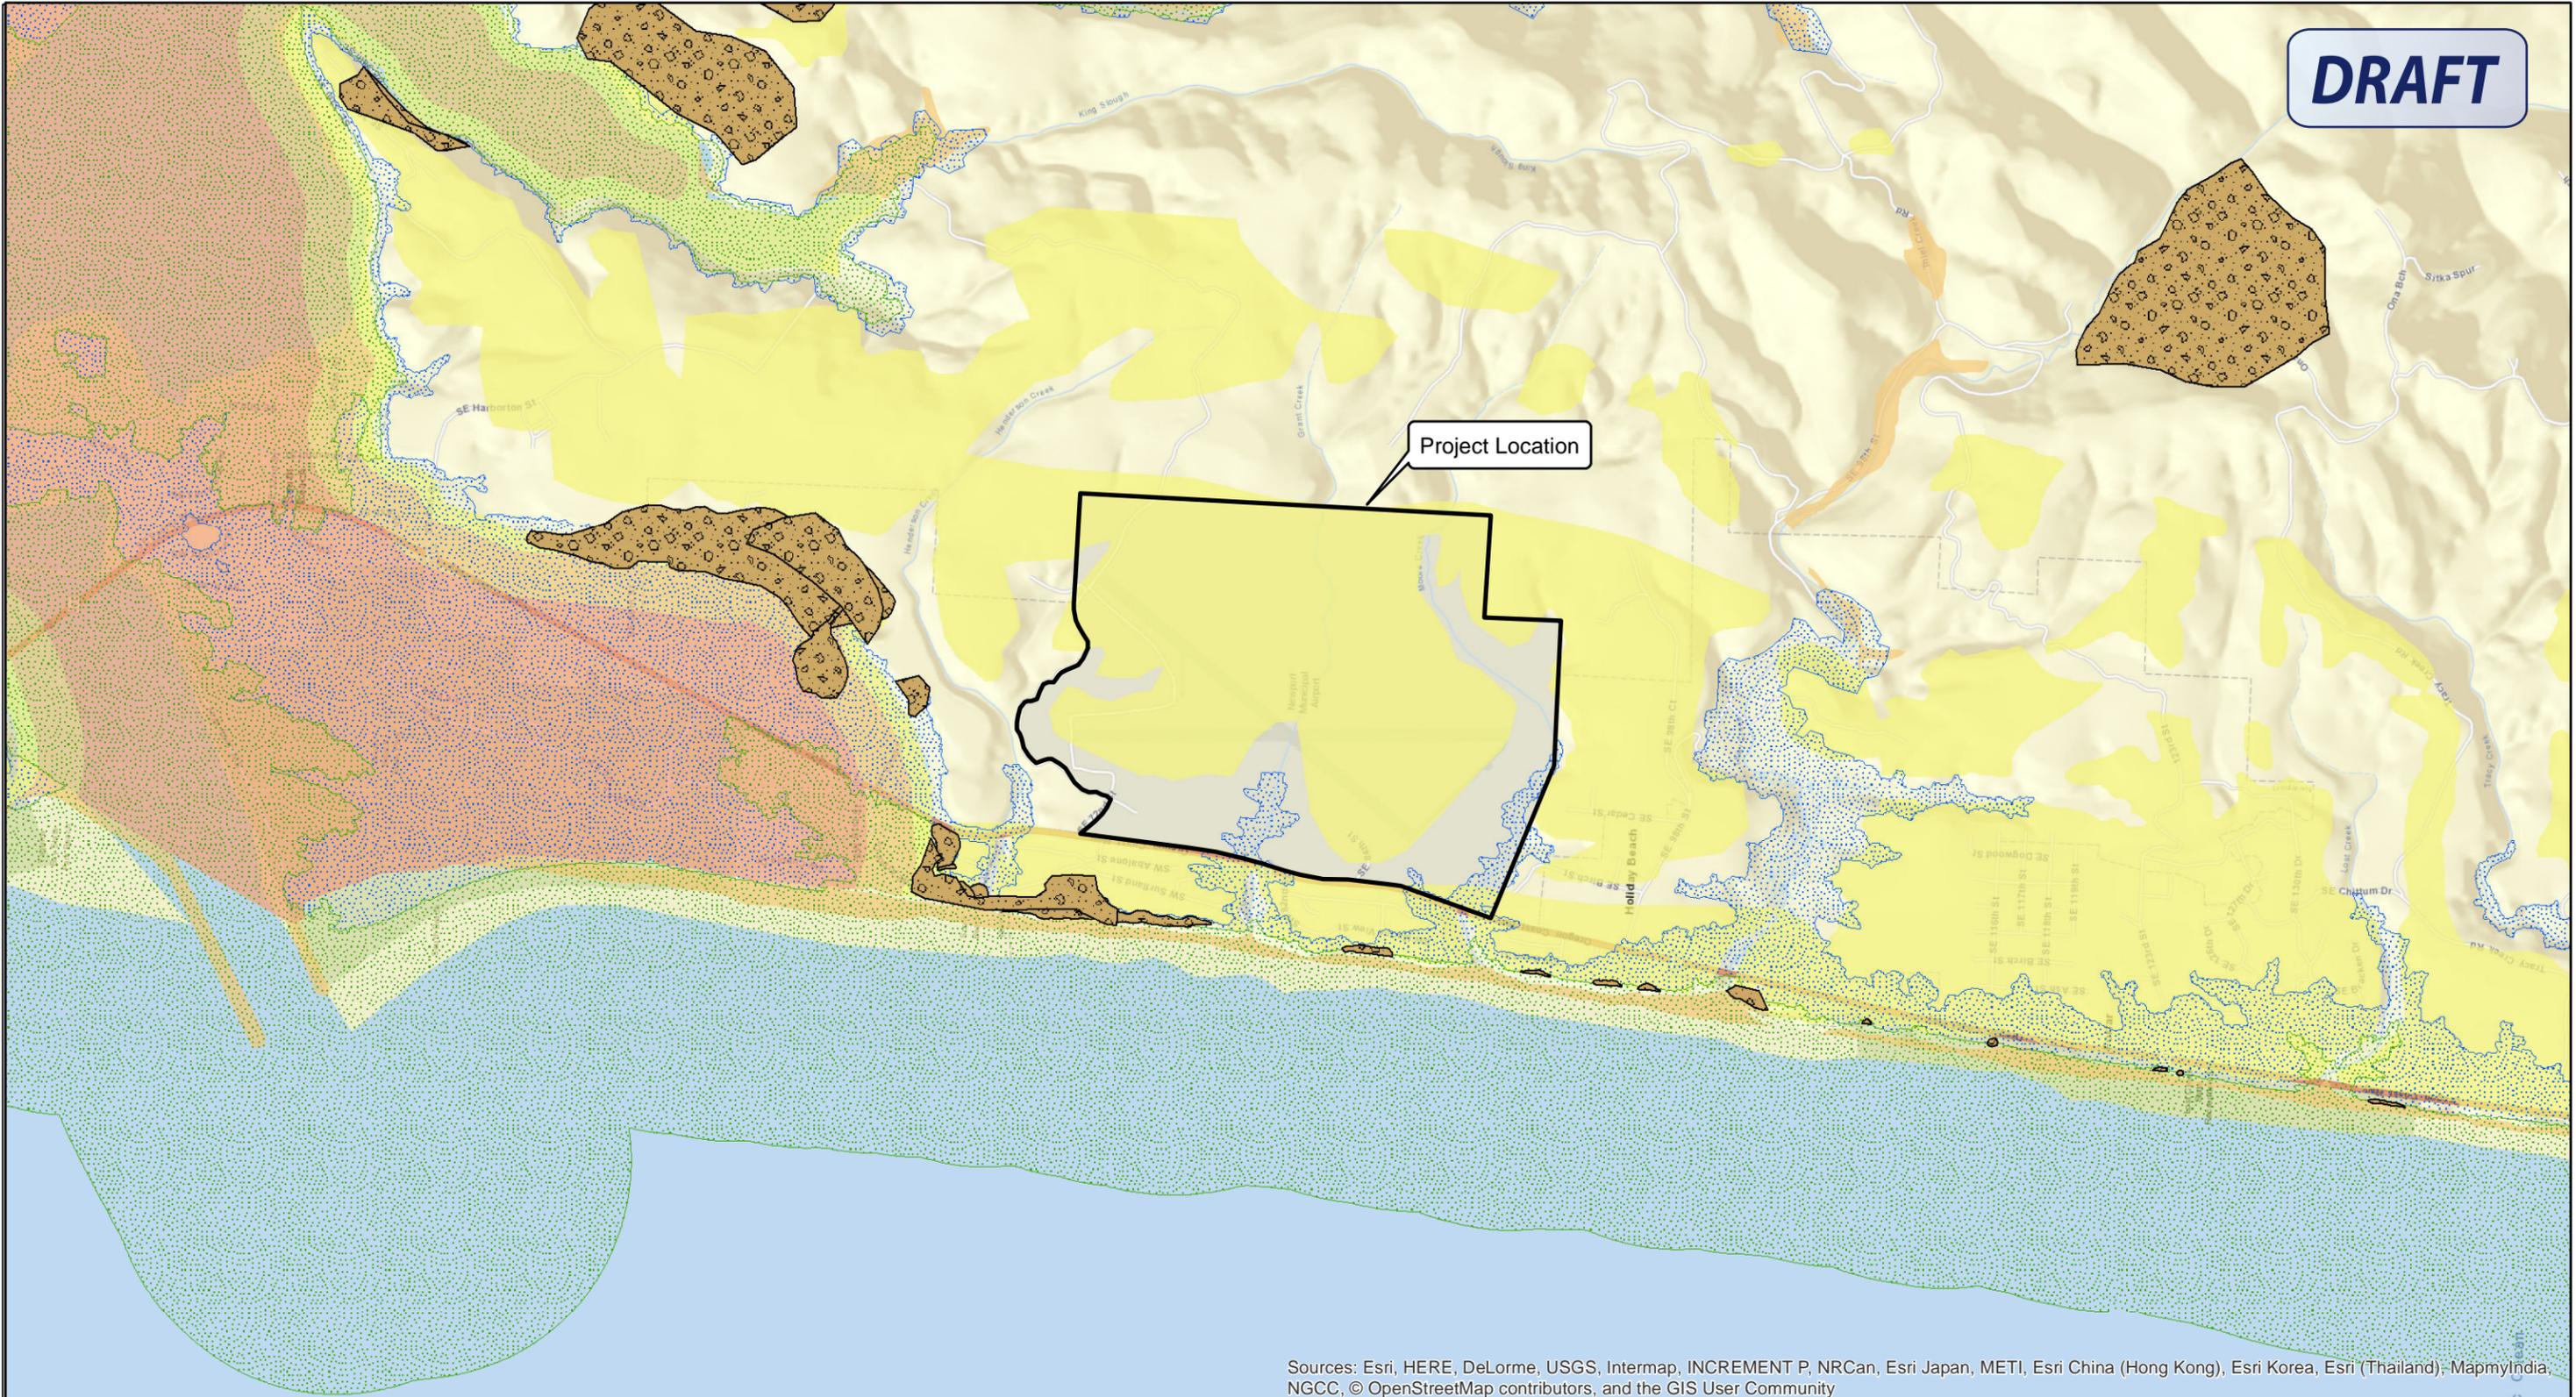
Newport Municipal Airport Newport, Oregon	
SLIDO, Liquefaction Susceptibility, and Tsunami Evacuation Zones	
154-035-009	1/18
	Figure 2

We reviewed the available information on seismic hazard, tsunami inundation information, and slope hazards. These hazard maps are included as Figure 2. Geotechnical, seismic and slope hazards are described in our preliminary geotechnical assessment for the site, which is included as Appendix A.

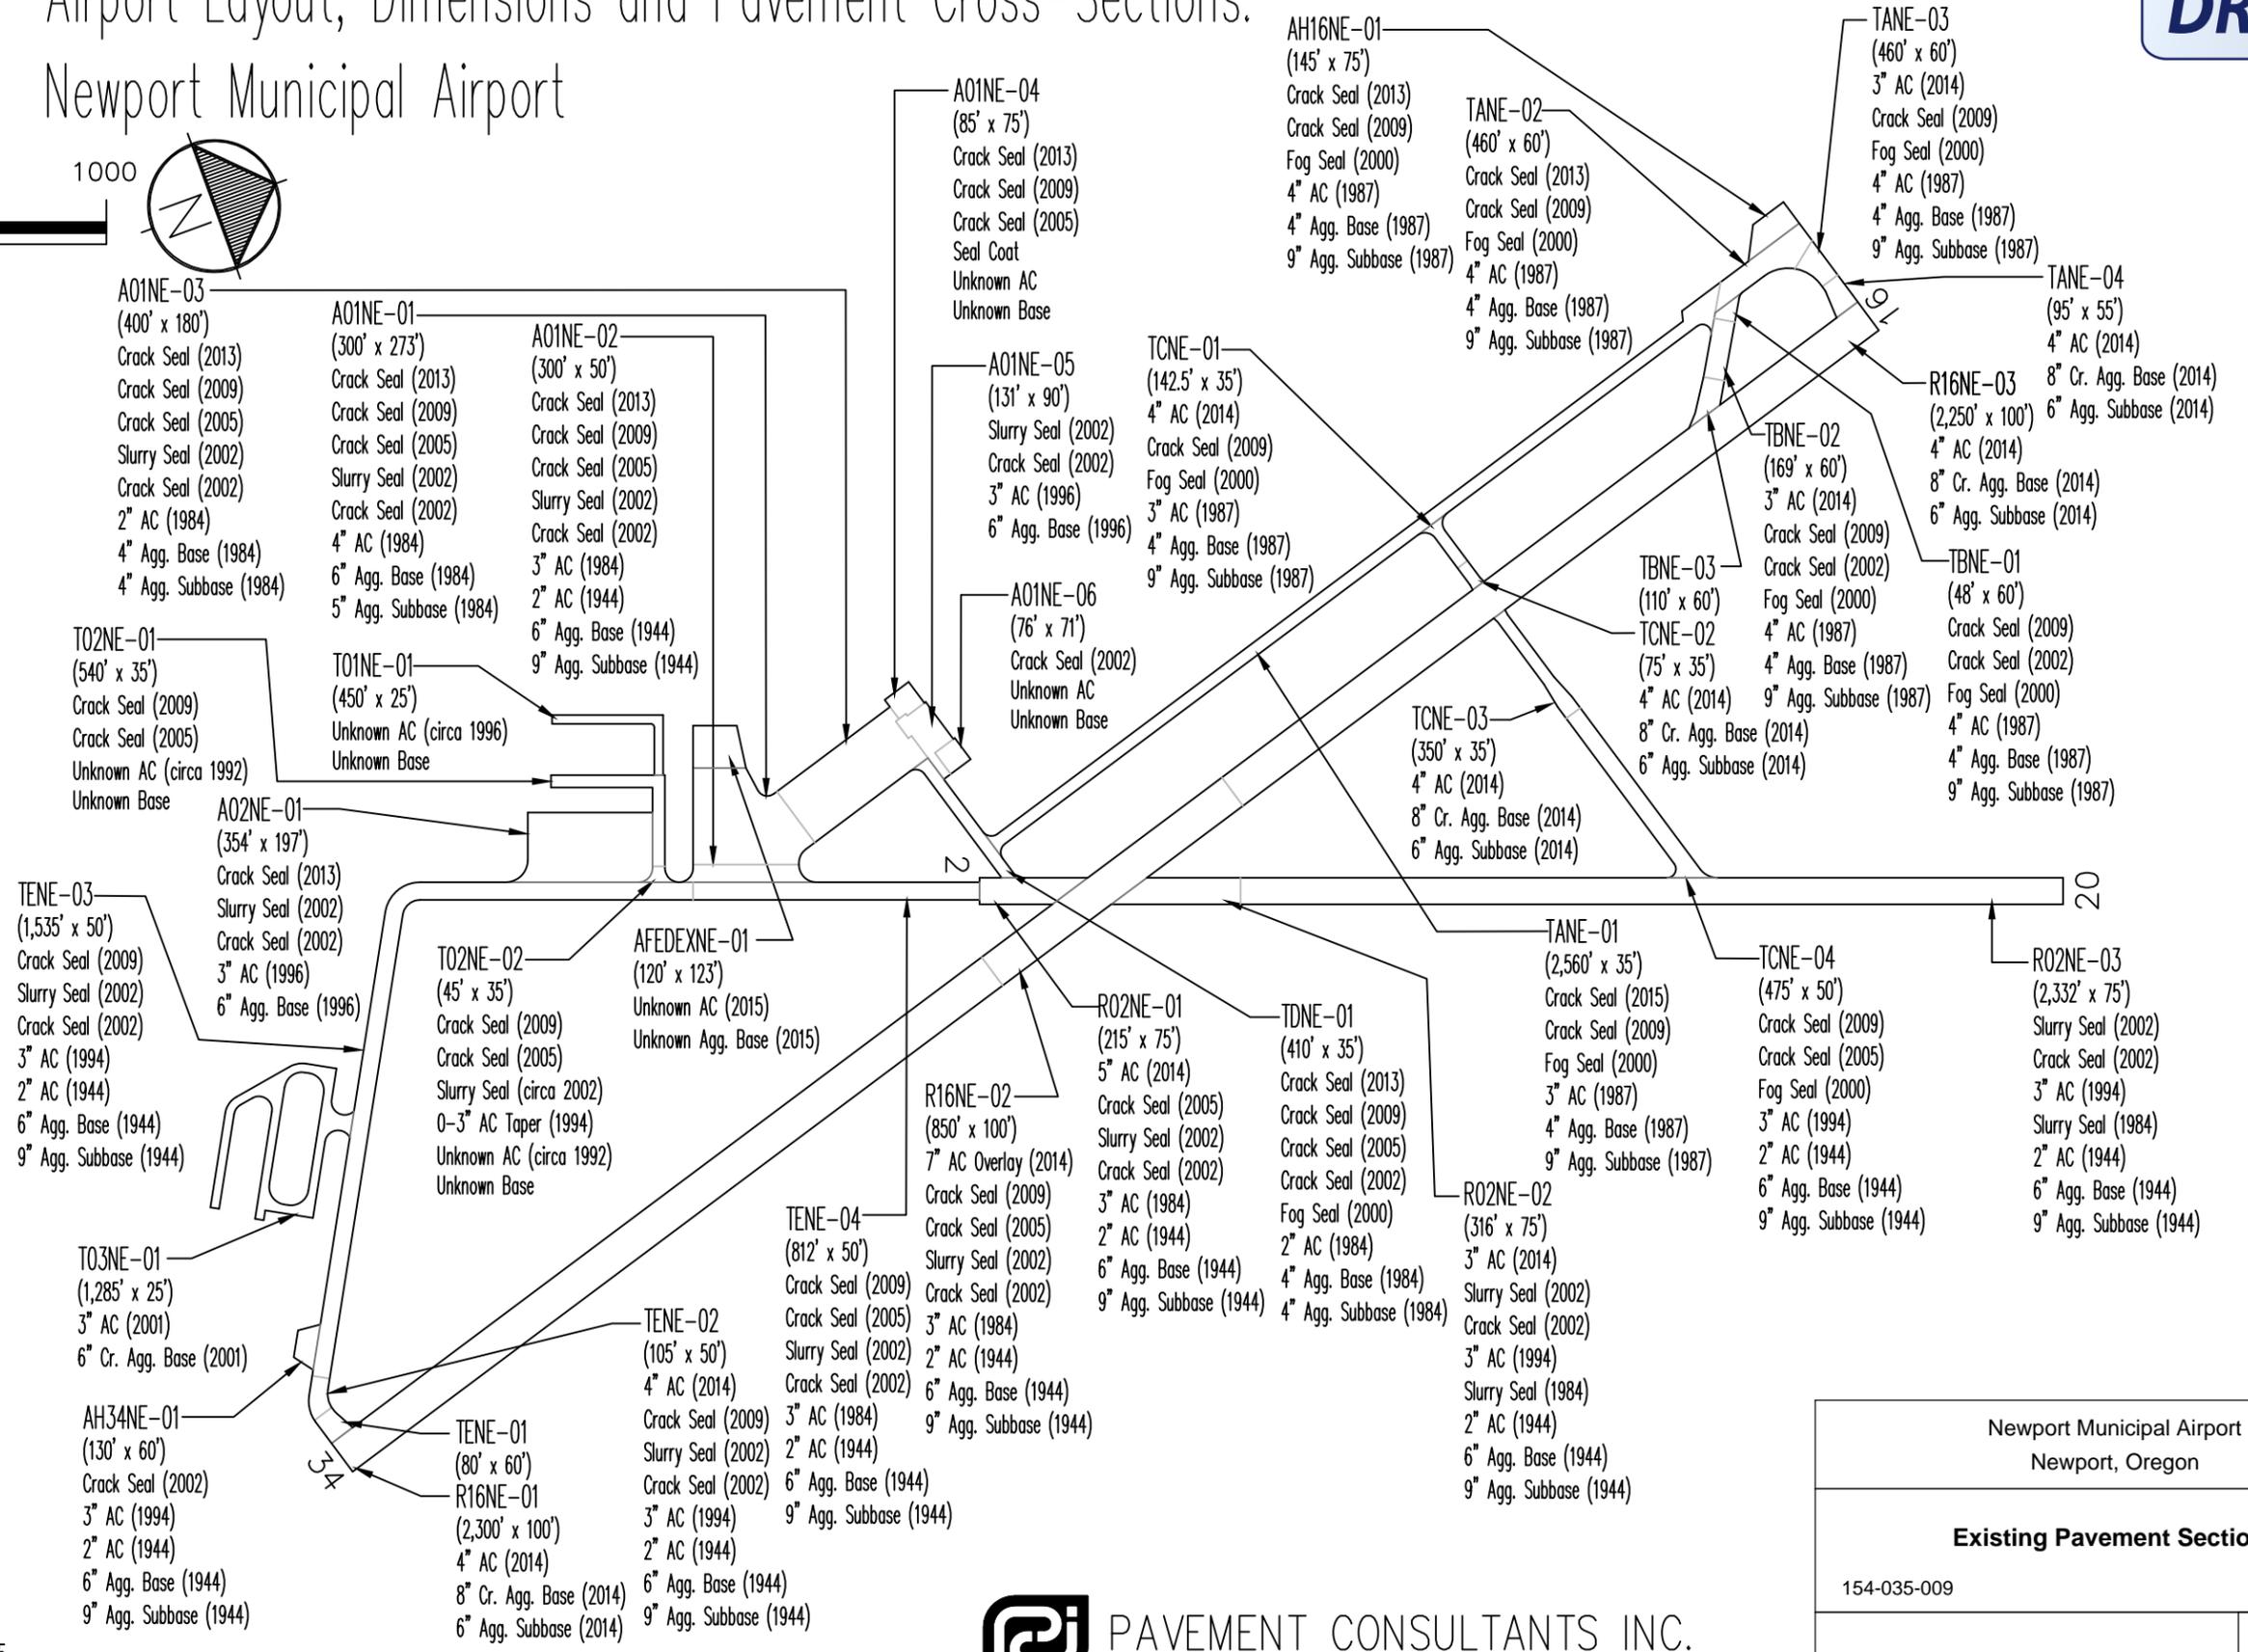
NEWPORT MUNICIPAL AIRPORT RESILIENCE ASSESSMENT	
EXISTING PAVEMENT COMPATIBILITY	
NPT010	2/18
 <small>5125 Southwest Hoyt Street Corvallis, OR 97333 541-754-0043</small>	
Figure 5

Existing pavement widths were evaluated for compatibility with the C-130 and C-17 Critical Response Aircraft. Given the relatively large “footprint” of these aircraft, they will be unable to operate on some pavements due to limitations of the existing pavement widths and insufficient pavement in turning areas. At present, the existing pavement geometry will support operations of both aircraft on Runway 16-34 and Taxiways A, B, and E, with some areas requiring judgmental oversteering. Existing pavement compatibility, including evaluation of the existing pavement geometry, is included on Figure 5.

Facility	Dimensions (Runways – Length x Width) (Taxiways – Width)	Surfacing/ Pavement Classification Number (PCN)	Does Facility Support Military Response Aircraft	Notes
Runway 16-34	5,398' x100' Declared Distances ¹	Asphalt Surface PCN- 37 /F/D/X/T ^b	C-130 – Yes C-17 – Yes, restricted Helicopters – Yes, as required	Significantly restricted allowable C-17 aircraft weight and/or number of operations; C-17 judgmental oversteering required, see Figure 5
Runway 2-20	3001'x75' Declared Distances – N/A	Asphalt Surface 15 /F/D/X/T ^b	C-130 – Yes, restricted C-17 – No, Limited by pavement width/strength Helicopters – Yes, as required	Significantly restricted allowable C-130 weight and/or number of operations, see Figure 5
Taxiway A	North of T/W B – 55'	Asphalt Surface PCN not available but pavement section thickness is less than Runway 16-34	C-130 – Yes, restricted C-17 – Yes, restricted Helicopters – Yes, as required	Restricted (significant in some cases) allowable aircraft weights and/or number of operations, C-17 judgmental oversteering required, see Figure 5

Facility	Dimensions (Runways – Length x Width) (Taxiways – Width)	Surfacing/ Pavement Classification Number (PCN)	Does Facility Support Military Response Aircraft	Notes
Taxiway B	50'	Asphalt Surface PCN varies but critical section thickness is less than Runway 16- 34	C-130 – Yes, restricted C-17 – Yes, restricted Helicopters – Yes, as required	Restricted (significant in some cases) allowable aircraft weights and/or number of operations, C-17 judgmental oversteering required, see Figure 5
Taxiway C	North of R/W 16-34 – 35' – 50'	Asphalt Surface PCN varies, pavement section thickness is similar to Runway 2-20	C-130 – Yes, restricted C-17 – No, Limited by pavement width Helicopters – Yes, as required	Significantly restricted allowable C-130 weight and/or number of operations, see Figure 5
	South of R/W 16-34 – 35'	Asphalt Surface PCN not available, Critical pavement section thickness is less than Runway 2-20	C-130 – No C-17 – No Helicopters – Yes, as required	Unable to accommodate aircraft turning movements to intersecting taxiways; Insufficient pavement section based on record drawings

Taxiway D	35'	Asphalt Surface PCN varies, critical pavement section thickness is similar to Runway 2-20	C-130 – No C-17 – No Helicopters – Yes, as required	Unable to accommodate aircraft turning movements to intersecting taxiways; Insufficient pavement section based on record drawings
Taxiway E	50'	Asphalt Surface PCN varies, critical pavement section thickness is similar to Runway 2-20	C-130 – Yes, restricted C-17 – Yes, restricted Helicopters – Yes, as required	Significantly restricted allowable aircraft weights and/or number of operations, see Figure 5
Aprons	27,000 square yards (Approximate)	Asphalt Surface PCN not calculated; Apron pavement thicknesses are less than Runway 2-20	C-130 – No C-17 – No Helicopters – Yes	Area includes apron taxi lanes Excludes USCG Apron (2,800 SY approximate); Insufficient pavement section for fixed wing aircraft based on record drawings

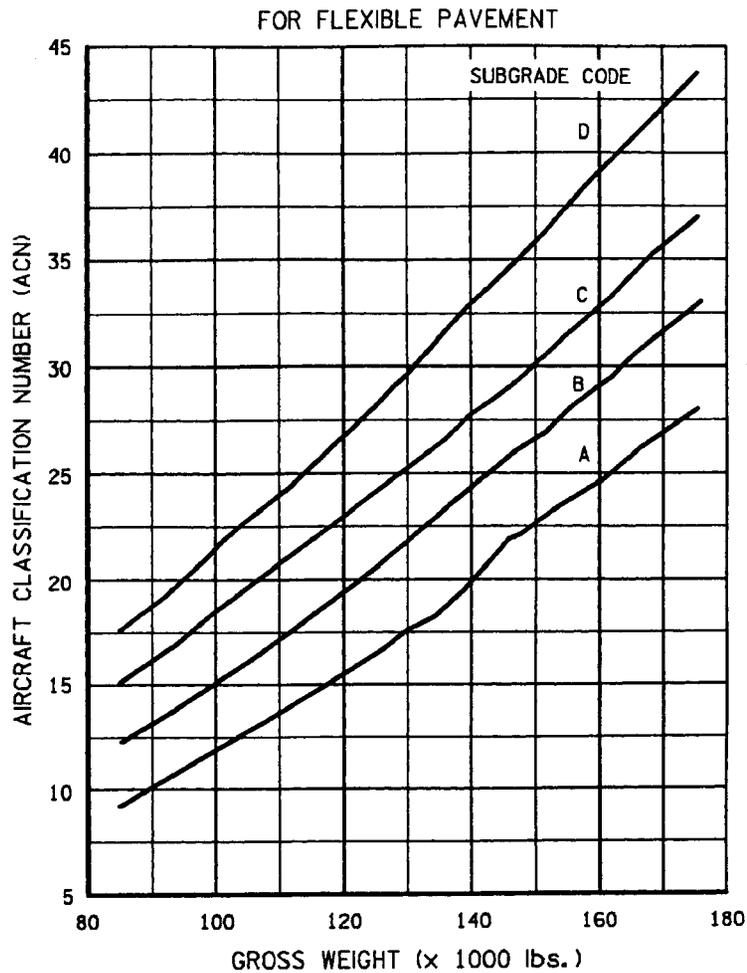
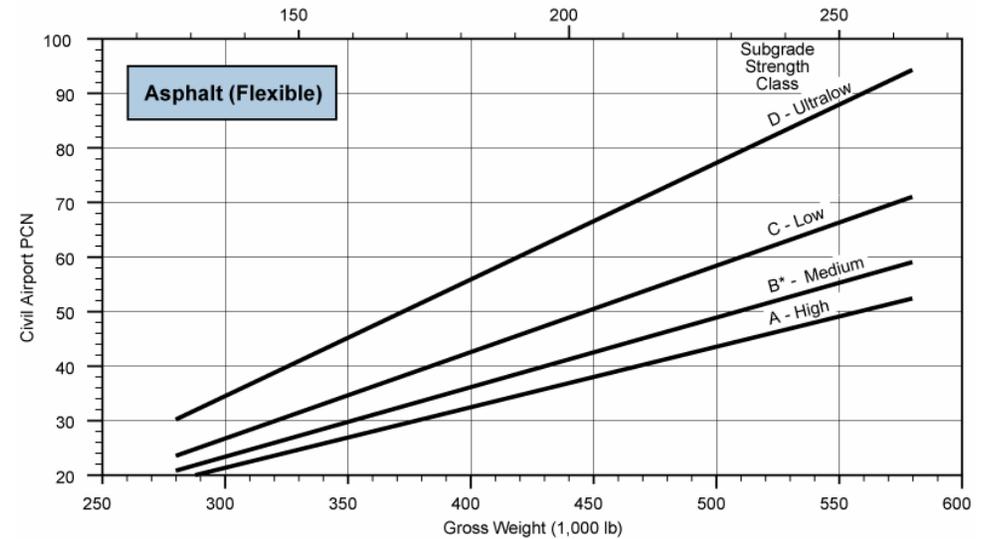
Newport Municipal Airport Newport, Oregon	
Aircraft Capacity Numbers	
154-035-009	1/18
Figure 6

The following list shows some approximate key ACNs for the critical response aircraft as obtained from the FAA’s COMFAA pavement software. Charts for ACN calculations of these aircraft at all weights are included on Figure 6. A summary of the existing available PCNs is included below in Table 5.
